Inspection report

Danesholme Juniors Academy Motala Close Corby NN18 9DT	Date Of Inspection: 28.2.22
Responsible Person: Nikki Lammond	Name Of Inspector(s): Geoff Slade
SEND Co: Dawn Reynolds	Relevant Contacts: Laura Russell-Mason (H&S Contact), John Blair (Site Manager)

220228 - Accessibility Plan

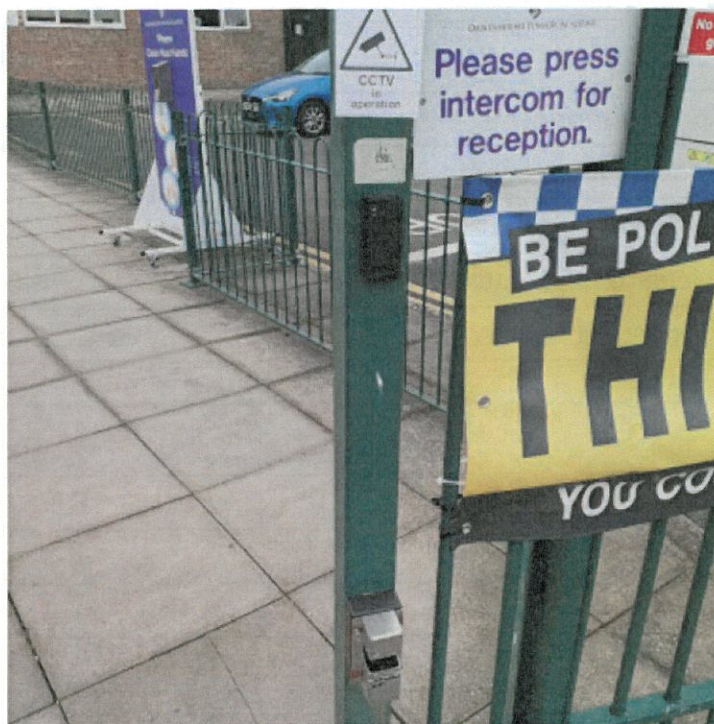
Carpark/Approach

FAIL - 6 MONTHS

Intercom at main reception gate too high.

Relocate to 1200mm from ground level

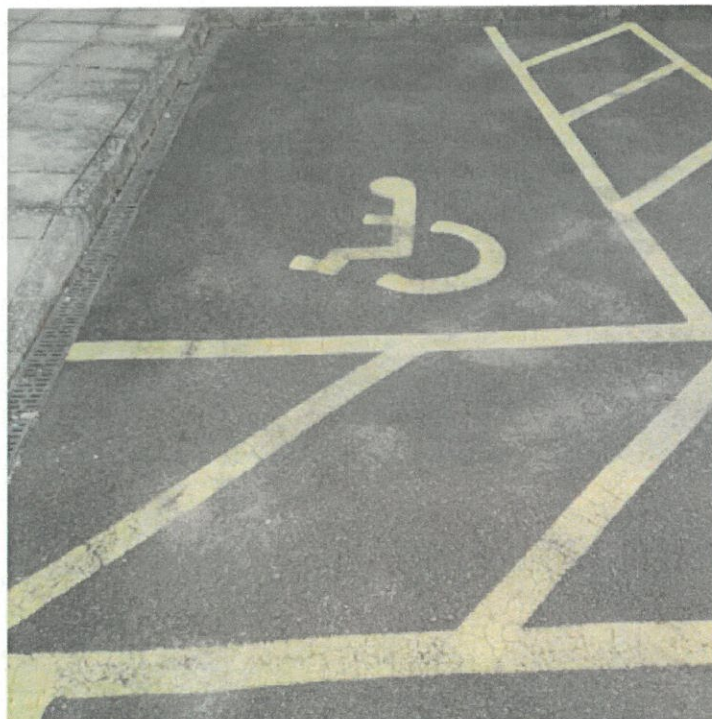
Carpark/Approach

PASS

Disabled parking bay clearly marked with
dropped kerb access to reception

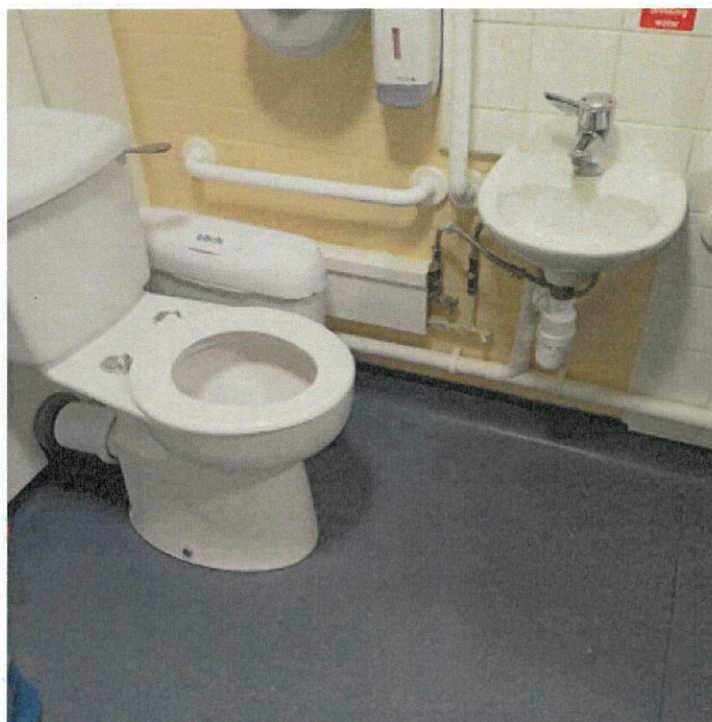
Accessible Toilets/Hygiene Rooms

FAIL - 1 MONTH

Fittings on sink and/or toilet not suitable for disabled people.

Toilet wrong height. Replace with standard adult height

Install fittings with paddle handles to toilets and/or sink.

Toilet handles should be on the open side. Tap should be on side closest to toilet.

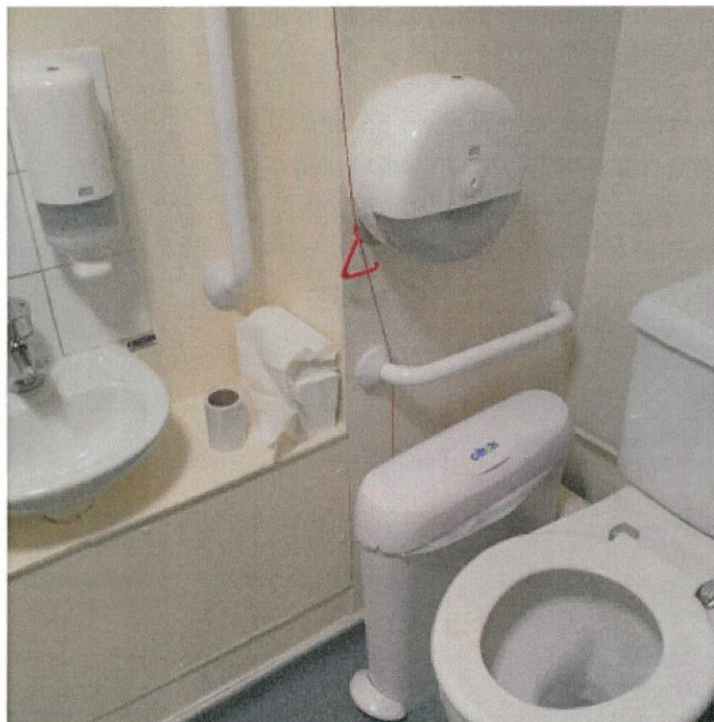
Accessible Toilets/Hygiene Rooms

FAIL - 1 MONTH

Insufficient contrast between fittings and background. Change rails and toilet seat to blue or dark grey

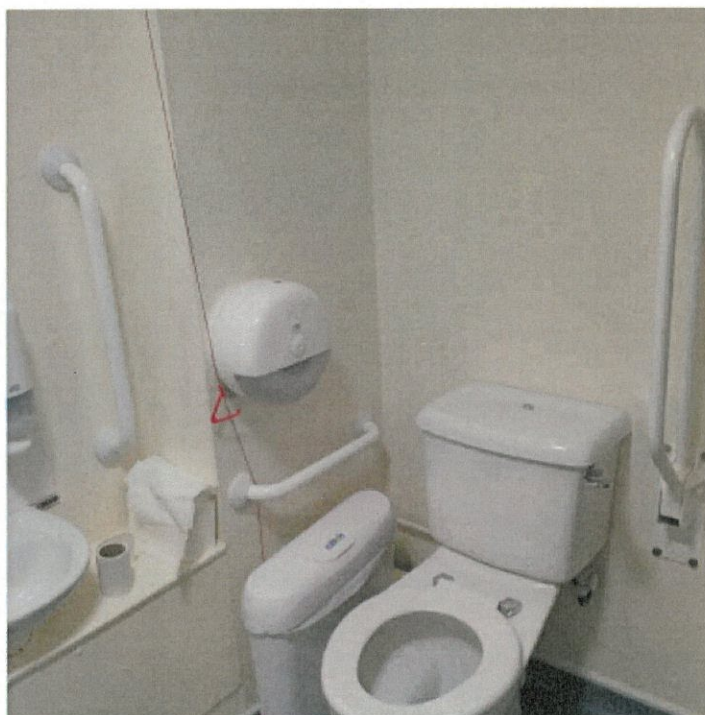
Accessible Toilets/Hygiene Rooms

FAIL - 1 MONTH

Fittings and consumables cannot be reached by person sitting on the toilet seat.

The sink, soap, toilet paper, and/or paper towels should be relocated to allow use whilst seated on the toilet.

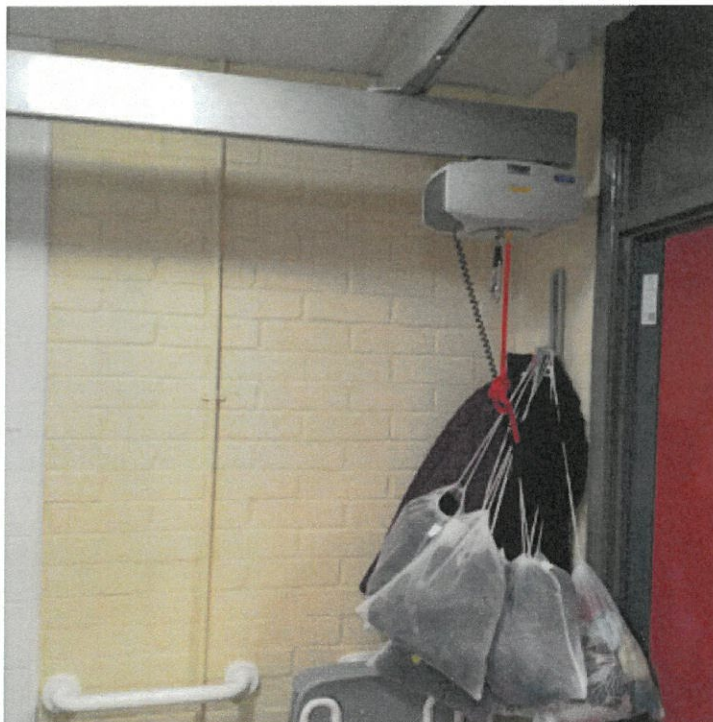
Accessible Toilets/Hygiene Rooms

FAIL - 1 MONTH

No evidence present to show hoist has been serviced within statutory requirements.

Acquire service records/arrange for a service program to be implemented ensuring equipment remains maintained within statutory requirements.

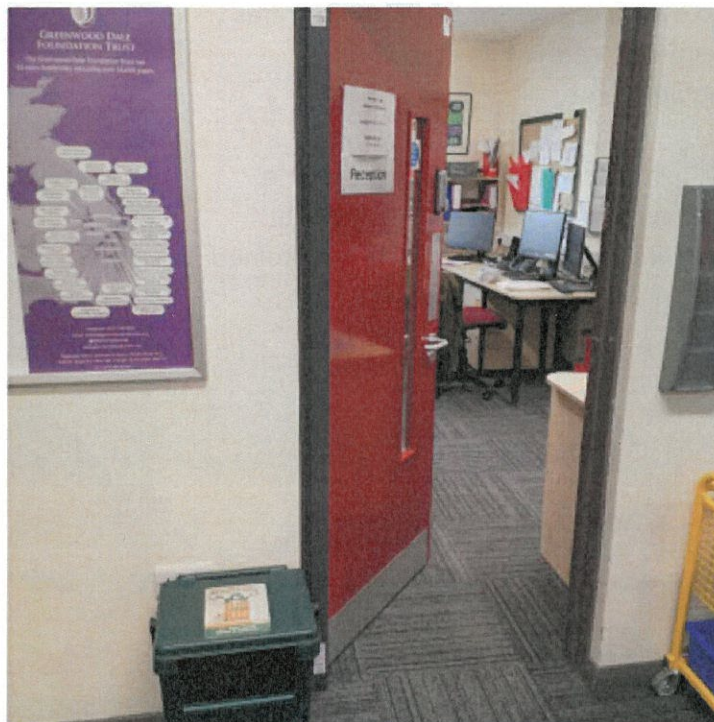
Hallways/Corridors

PASS

Good contrast with doors, furniture, walls and flooring

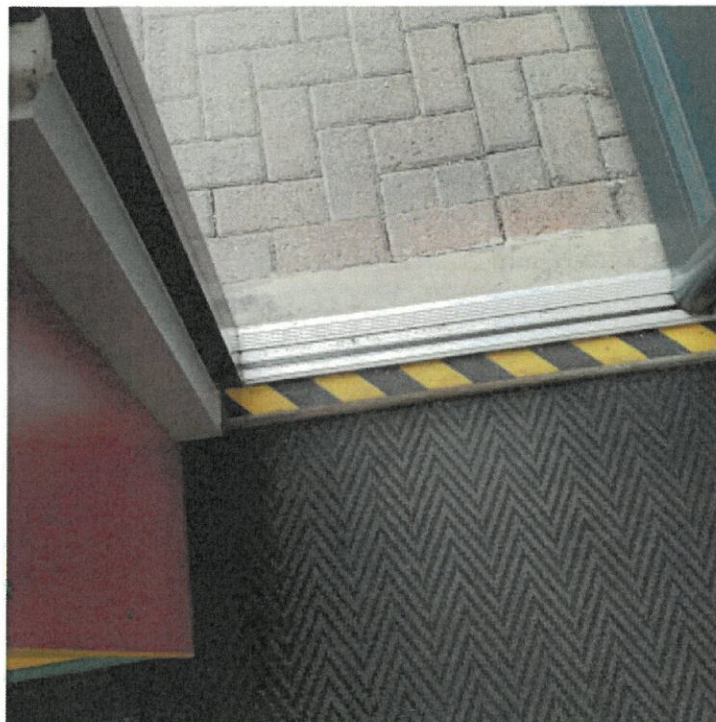
Stairs/Steps/Ramps/Lifts

FAIL - IMMEDIATE

Edgings of steps/ stairs are damaged/ not marked.

Mark edges of steps/stairs with a slip resistant and contrasting nosing extending along the full width of the step to a depth of 50mm on tread and riser

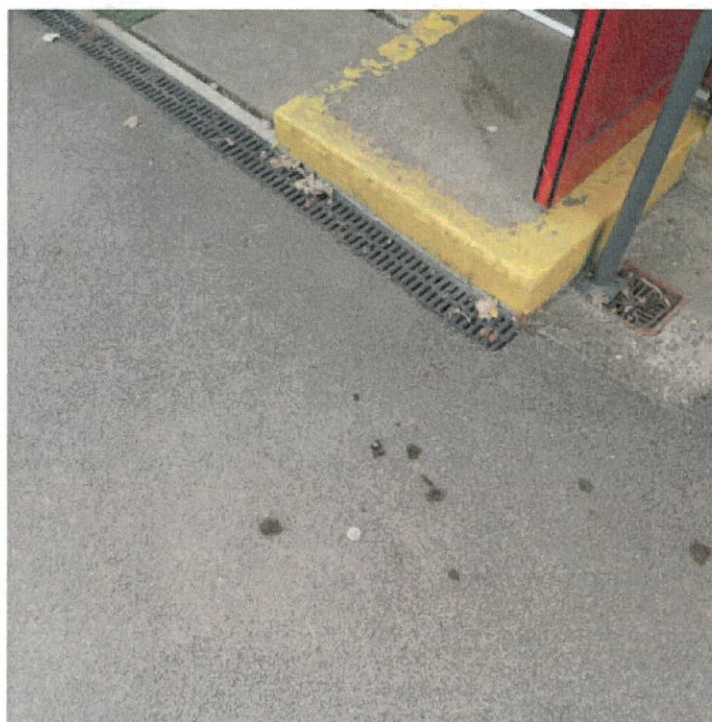
Stairs/Steps/Ramps/Lifts

FAIL - 1 MONTH

Edgings of steps/ stairs are damaged/ not marked.

Mark edges of steps/stairs with a slip resistant and contrasting nosing extending along the full width of the step to a depth of 50mm on tread and riser

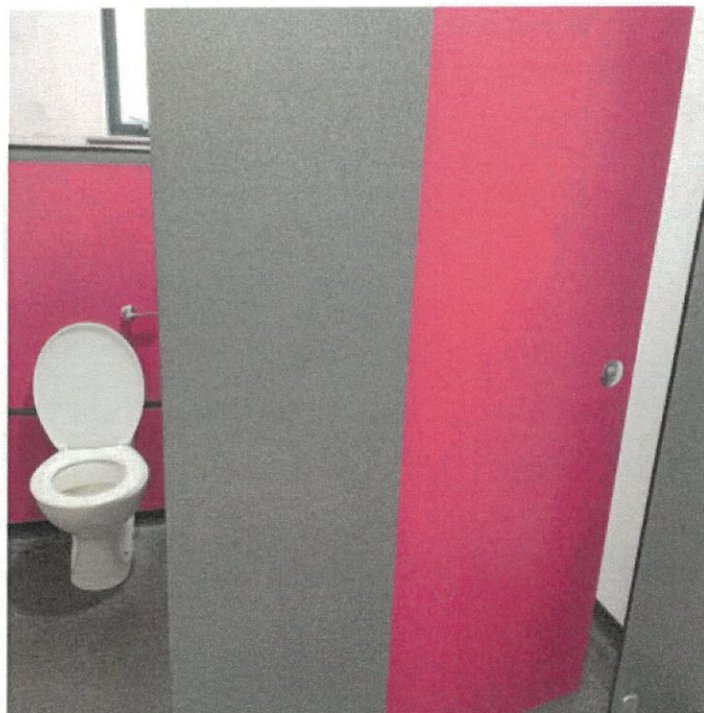
Classrooms/Communal areas

FAIL - 1 MONTH

Insufficient contrast between doors and frames.

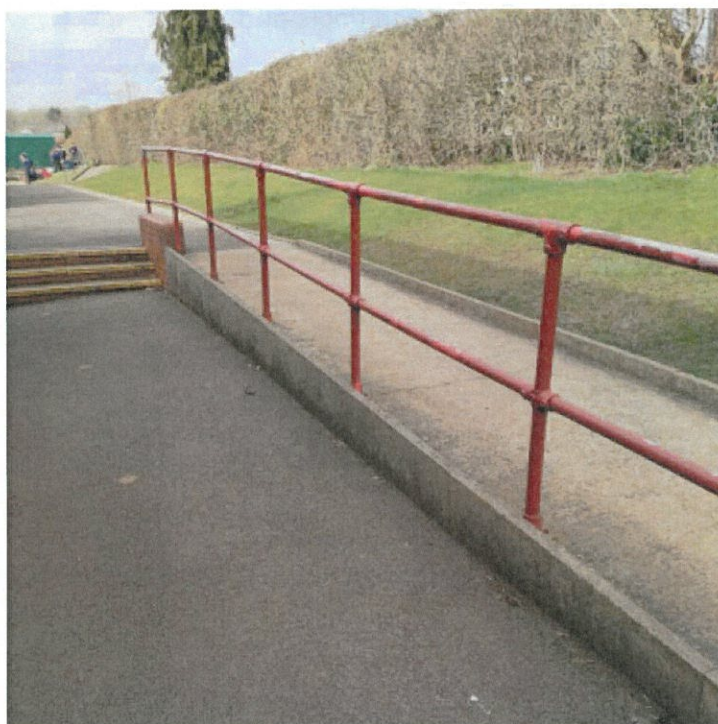
External areas/Playgrounds

PASS

Access ramps available with sufficient guardrails.
